Re: Manweiler Trucking Spill
Colorado Springs, El Paso County, Colorado
TDD: 0002/1608-11
DCN: W0404.1A.01132
WO#: 20408.012.002.0404.00

FIGURE 1 SITE LOCATION MAP MANWEILER TRUCKING SPILL COLORADO SPRINGS, COLORADO

FIGURE 2 RESPONSE ACTIVITIES MAP MANWEILER TRUCKING SPILL COLORADO SPRINGS, COLORADO

Manweiler Trucking Spill

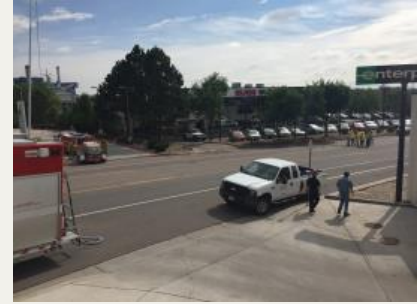
Description: View of where the tanker truck overturned on Motor City Drive. Tanker overturned at approximately 4 am on August 26, 2016 with approximately 6,000 gallons of gasoline and 2,000 gallons of diesel fuel.

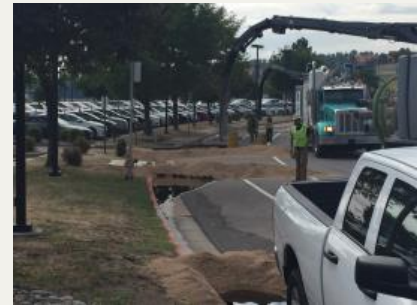
Description: View of berms placed on Motor City Drive to capture remnant gasoline and diesel spilled from overturned tanker prior to the contaminants reaching the storm sewer.

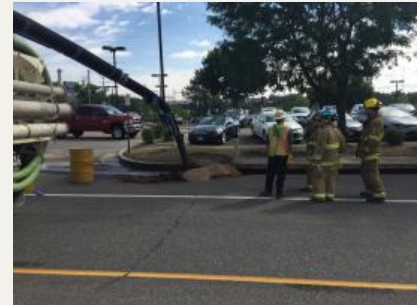
Description: Clean up contractor, Belfor, using a vac-truck to suck up contaminants which were collected by one of four berms set up on Motor City Drive.

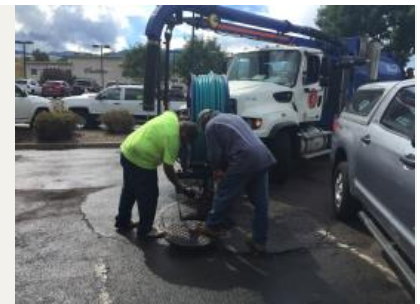
Description: Belfor contractors "jetting" stormwater sewer in order to wash the contaminants from the sewer.

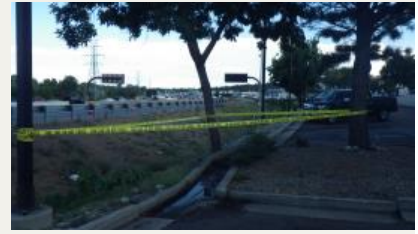
Description: Storm Water Drain number 2 located east of the spill area behind the nearby car dealership. Photo taken post cleanout. Note the caution tape. The hole has been temporarily covered with plywood. No visible sheen post cleanout.

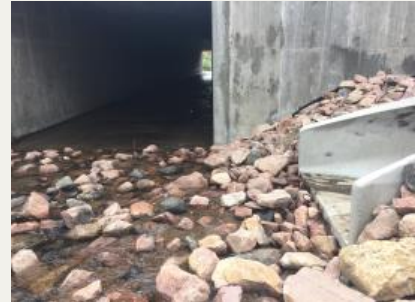
Description: Outfall of the stormwater sewer into Bear Creek near the overturned tanker. Water flows away from the camera, through the highway culvert and into Fountain Creek.

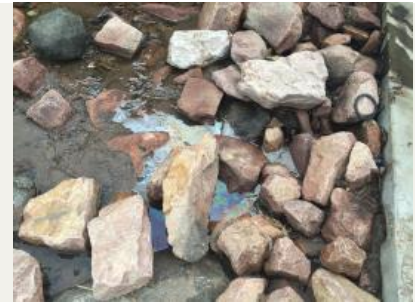
Description: Sheen coming from the outfall of the stormwater sewer and into Bear Creek.

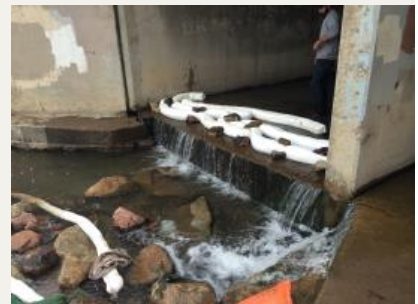
Description: Absorbent tubes placed in Bear Creek just downstream of the stormwater sewer and on the other side of the I25 highway culvert.

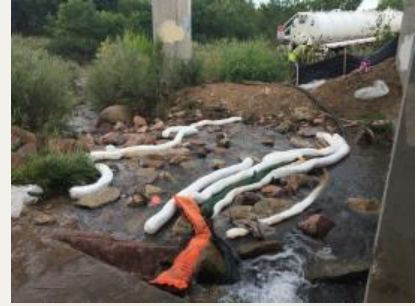
Description: Secondary absorbent tubes placed in Bear Creek just downstream of the stormwater sewer discharge on the downstream end of the I25 highway culvert. Belfor contractor is using a vac-truck to remove contaminants from the creek.

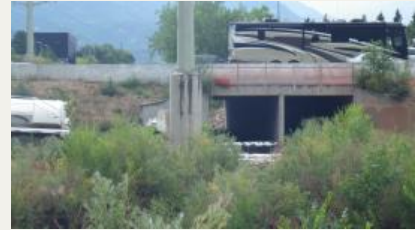
Description: Absorbent tubes on Bear Creek before confluence with Fountain Creek. Response contractor continued to monitor and observe this area, switching out tubes when needed.

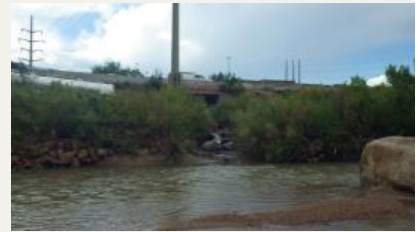
Description: Confluence of Bear Creek and Fountain Creek, no visible sheen or odor on this side of Fountain Creek. Response team is deploying absorbent tubes and removing product using a vacuum truck.

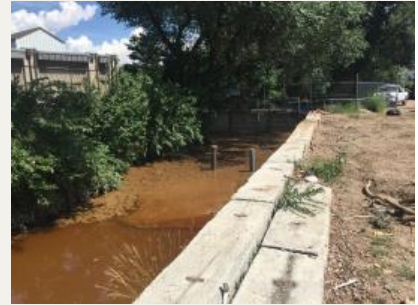
Description: Water and product in front of the closed agricultural water intake near the Las Vegas Waste Water Treatment Facility. Product was approximately 6 inches deep, 15 feet across, and 60 feet long. Photo taken at 1250 on 8/26/2016. Sample TS-SW-01-20160826 was collected from this location. Sample TS-SW-02-20160826 was collected from the opposite side of the gates. The sample did not contain any product.

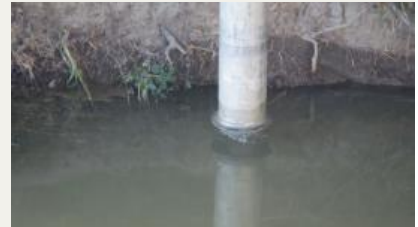
Description: Belfor removing diesel product from the agricultural water diversion near the Las Vegas Waste Water Facility.

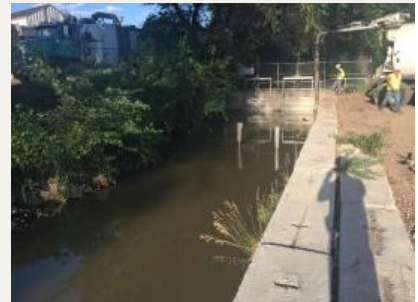
Description: Water in front of the closed agricultural water intake near the Las Vegas Waste Water Treatment Facility. Photo taken at 1811 on 8/26/2016 after product had been removed.

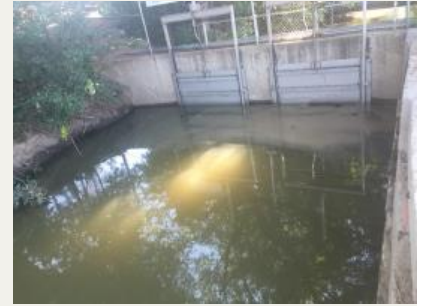
Description: Product at the agricultural water intake near the Las Vegas Waste Water Treatment Facility. The gates were left closed overnight to collect any sheen and product that continued to flow down stream from the spill site. There is a small amount of product in this image. This product was removed.

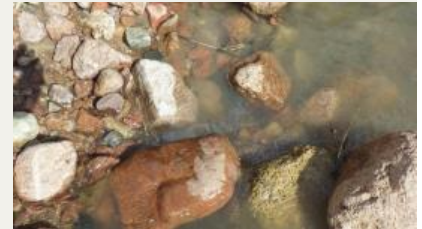
Description: Looking down on the East bank. Visible sheen along the slower moving water. No staining on the bank. No odor along the bank but slight odor when you walk away from the river.

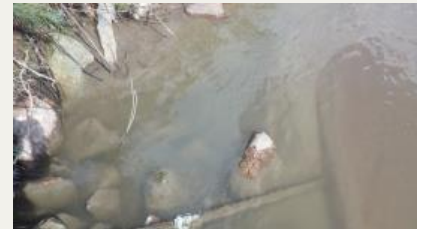
Description: Observation area down river from the confluence and on the east bank of Fountain Creek. Slower moving water with light visible sheen. Inorganic odor is present.

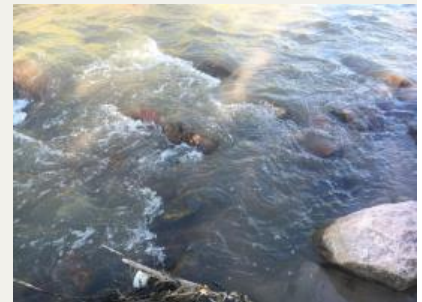
Description: Previous observation location of 8-26-2016. Slight visible sheen and faint odor near the slower moving water on 8-27-16. No visible staining on the bank. Observation location in on the west side of the Fountain Creek.

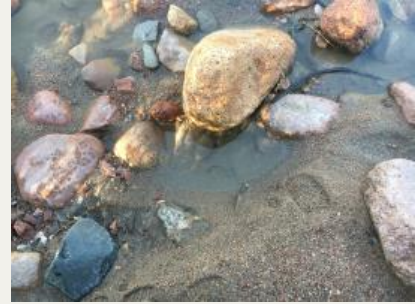
Description: Previous observation location of 8-26-2016. Visible sheen and slight odor still present on 8-27-16. No visible staining on the bank. Observation location in on the west side of the Fountain Creek.

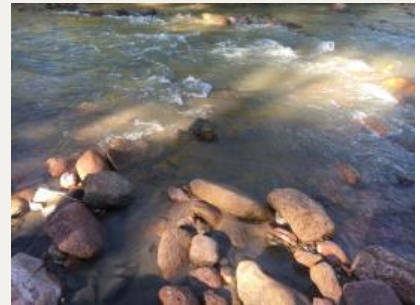
Description: Previous observation location of 8-26-2016. No visible sheen or odor on 8-27-16. No visible staining on the bank. Observation location in on the west side of the Fountain Creek.

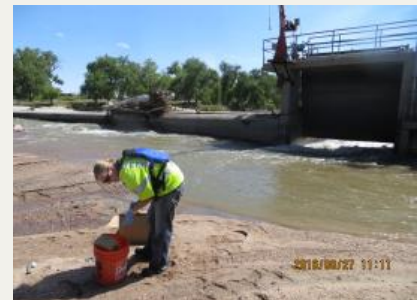
Description: START obtaining water sample from flow control structure along Fountain Creek where the second boom was located.

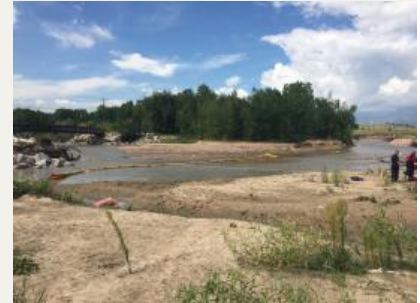
Description: Precautionary boom was deployed by the Fountain Fire Department near 323 Grinde Drive (Boom 1) at approximately 1100 on August 26. The Federal On Scene Coordinator (FOSC) had this boom removed as only a moderate amount of sheen was witnessed at this location.

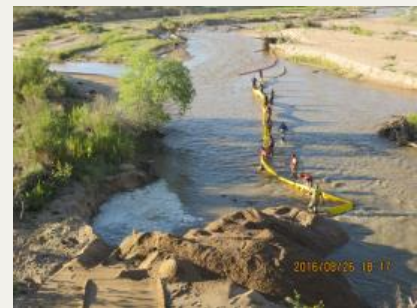
Description: Pueblo County Fire and Sheriff Departments constructing boom 3 on Fountain Creek near Piñon Bridge and I25 mile marker 110. The FOSC directed the responders to stop excavating in the river channel and eventually halted the boom deployment due to safety concerns, the unlikelihood of product reaching this location and the overall inability of boom to collect sheen.

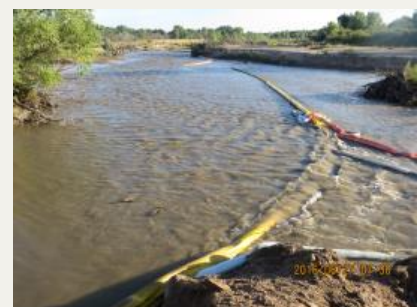
Description: Boom the morning after the FOSC halted its deployment and before it was retrieved. Sample TS-SW-08-20160827 was collected at this location.
